MCF5282 Device Errata

This document identifies implementation differences between the MCF5282 processor and the description contained in the *MCF5282 ColdFire® Microcontroller User's Manual*. Refer to <http://motorola.com/ColdFire> for the latest updates. The errata items listed in this document (summarized in [Table 1](#)) describe differences from the following documents:

MCF5282DE
Rev. 1.5
08/2004

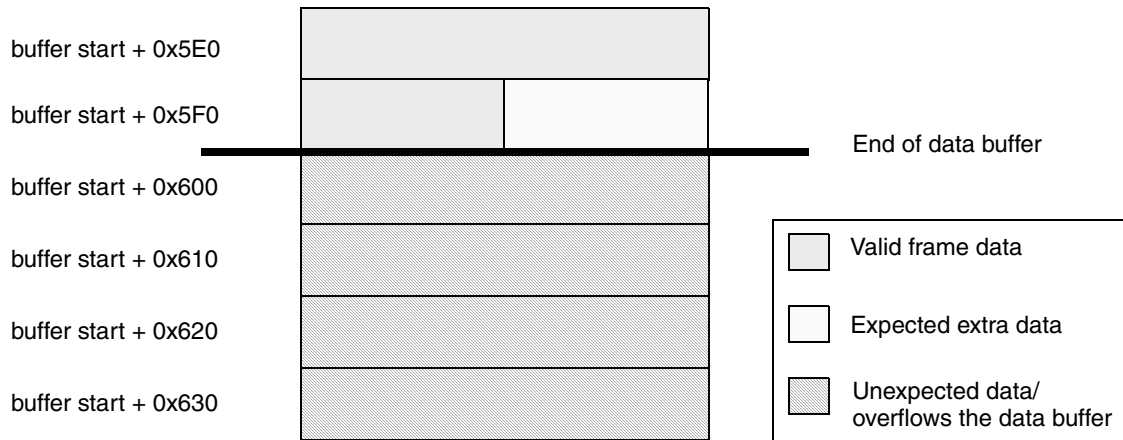
Figure 1. Buffer Overrun Example

When the FEC is connected to a 10BaseT network, if length of the data stored in a descriptor is not evenly divisible by 16 (not line-aligned), then the FEC will write extra lines at the end of the buffer—the entire line that contains the last valid data is written and at least one extra line, but up to four lines after the end of the valid data can also be written. In most cases this is not a problem, since the extra lines of data still fall within the limits of the buffer. However, if the valid data ends near the end of the buffer, then the extra lines written by the FEC might be outside of the data buffer. This leads to corruption of the next buffer, descriptor, data, or code stored in the adjacent memory.

For example, as shown in [Figure 1](#), if the max buffer size is programmed to 0x600 and a frame that is 0x5F8 bytes long is received, then a line is written starting at buffer start + 0x5F0. The first half of the line at buffer start + 0x5F0 is valid frame data that should be processed by the FEC driver; the second half of the line is additional data that is written because the FEC will only write complete lines. This data should be ignored by the FEC driver. So far, this is correct FEC behavior as originally specified. However, the FEC will repeat the last line of valid data a number of times. The line at buffer start + 0x600 will be written, and as many as three additional lines beyond the end of the data buffer could be written.

There are three independent workarounds:

1. Only use 100BaseT.
2. Allocate extra lines for the receive data buffers. The actual allocated memory for each buffer should be equal to the receive buffer size programmed in the FEC's EMRBR register plus four lines (16 byte-sized lines).
3. Program the data buffer size one line larger than the max packet size (data buffer size = EMRBR + 0x40).
